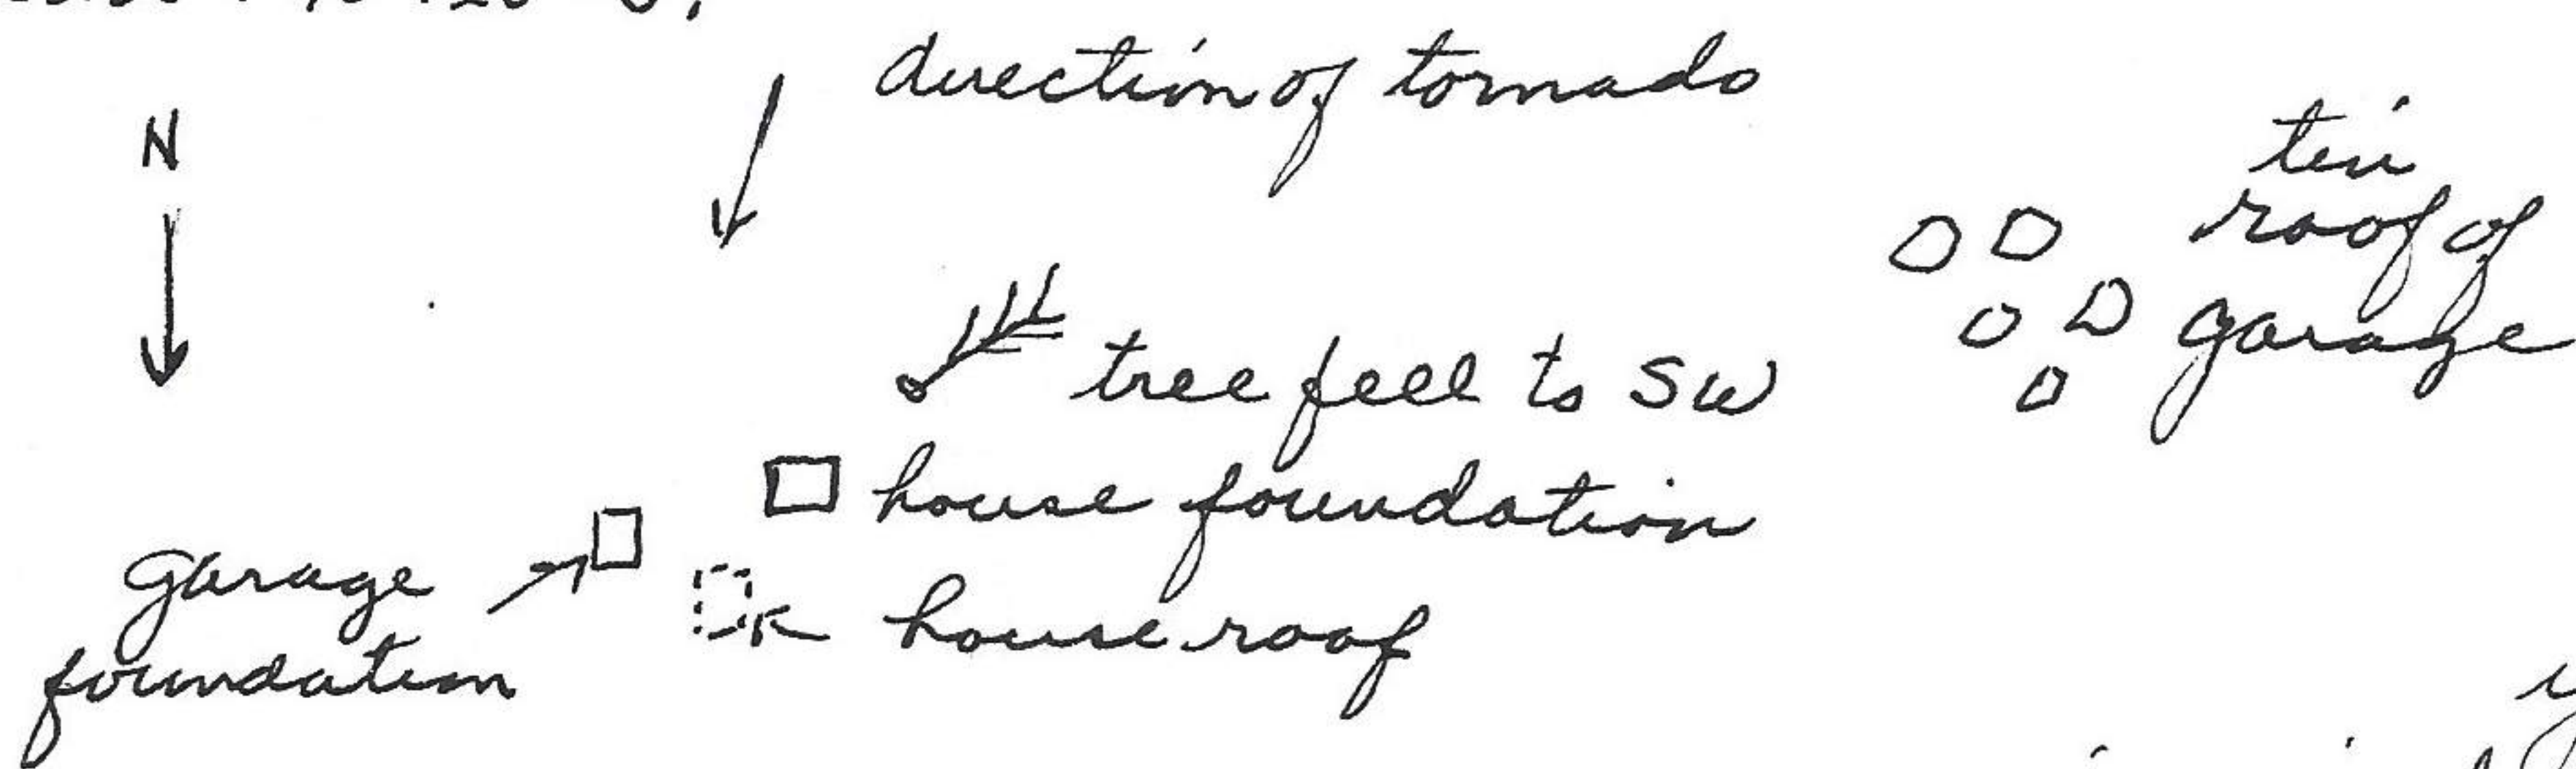
Continued south to Lewis residence (see map) and photographed the remains of this two story house, 640425-4 and 640425-5.

This home was completely demolished and lumber scattered in all direction. An 84

year old occupant was injured and found outside of house. The tree fell in usual direction but the roof of the house was blown from house in direction of the tornado. The metal roof of garage was 200-300 feet away and in same direction from the garage as the direction of the tree. This house is on the N side of the valley slope and at the base or valley level.
