Kaw River, Douglas Co., Kansas
Feb. 24, 1974

Mary Pauline and I inspected Kaw River at first curve east of Lawrence for degree of bank erosion. Degree of erosion since 1950

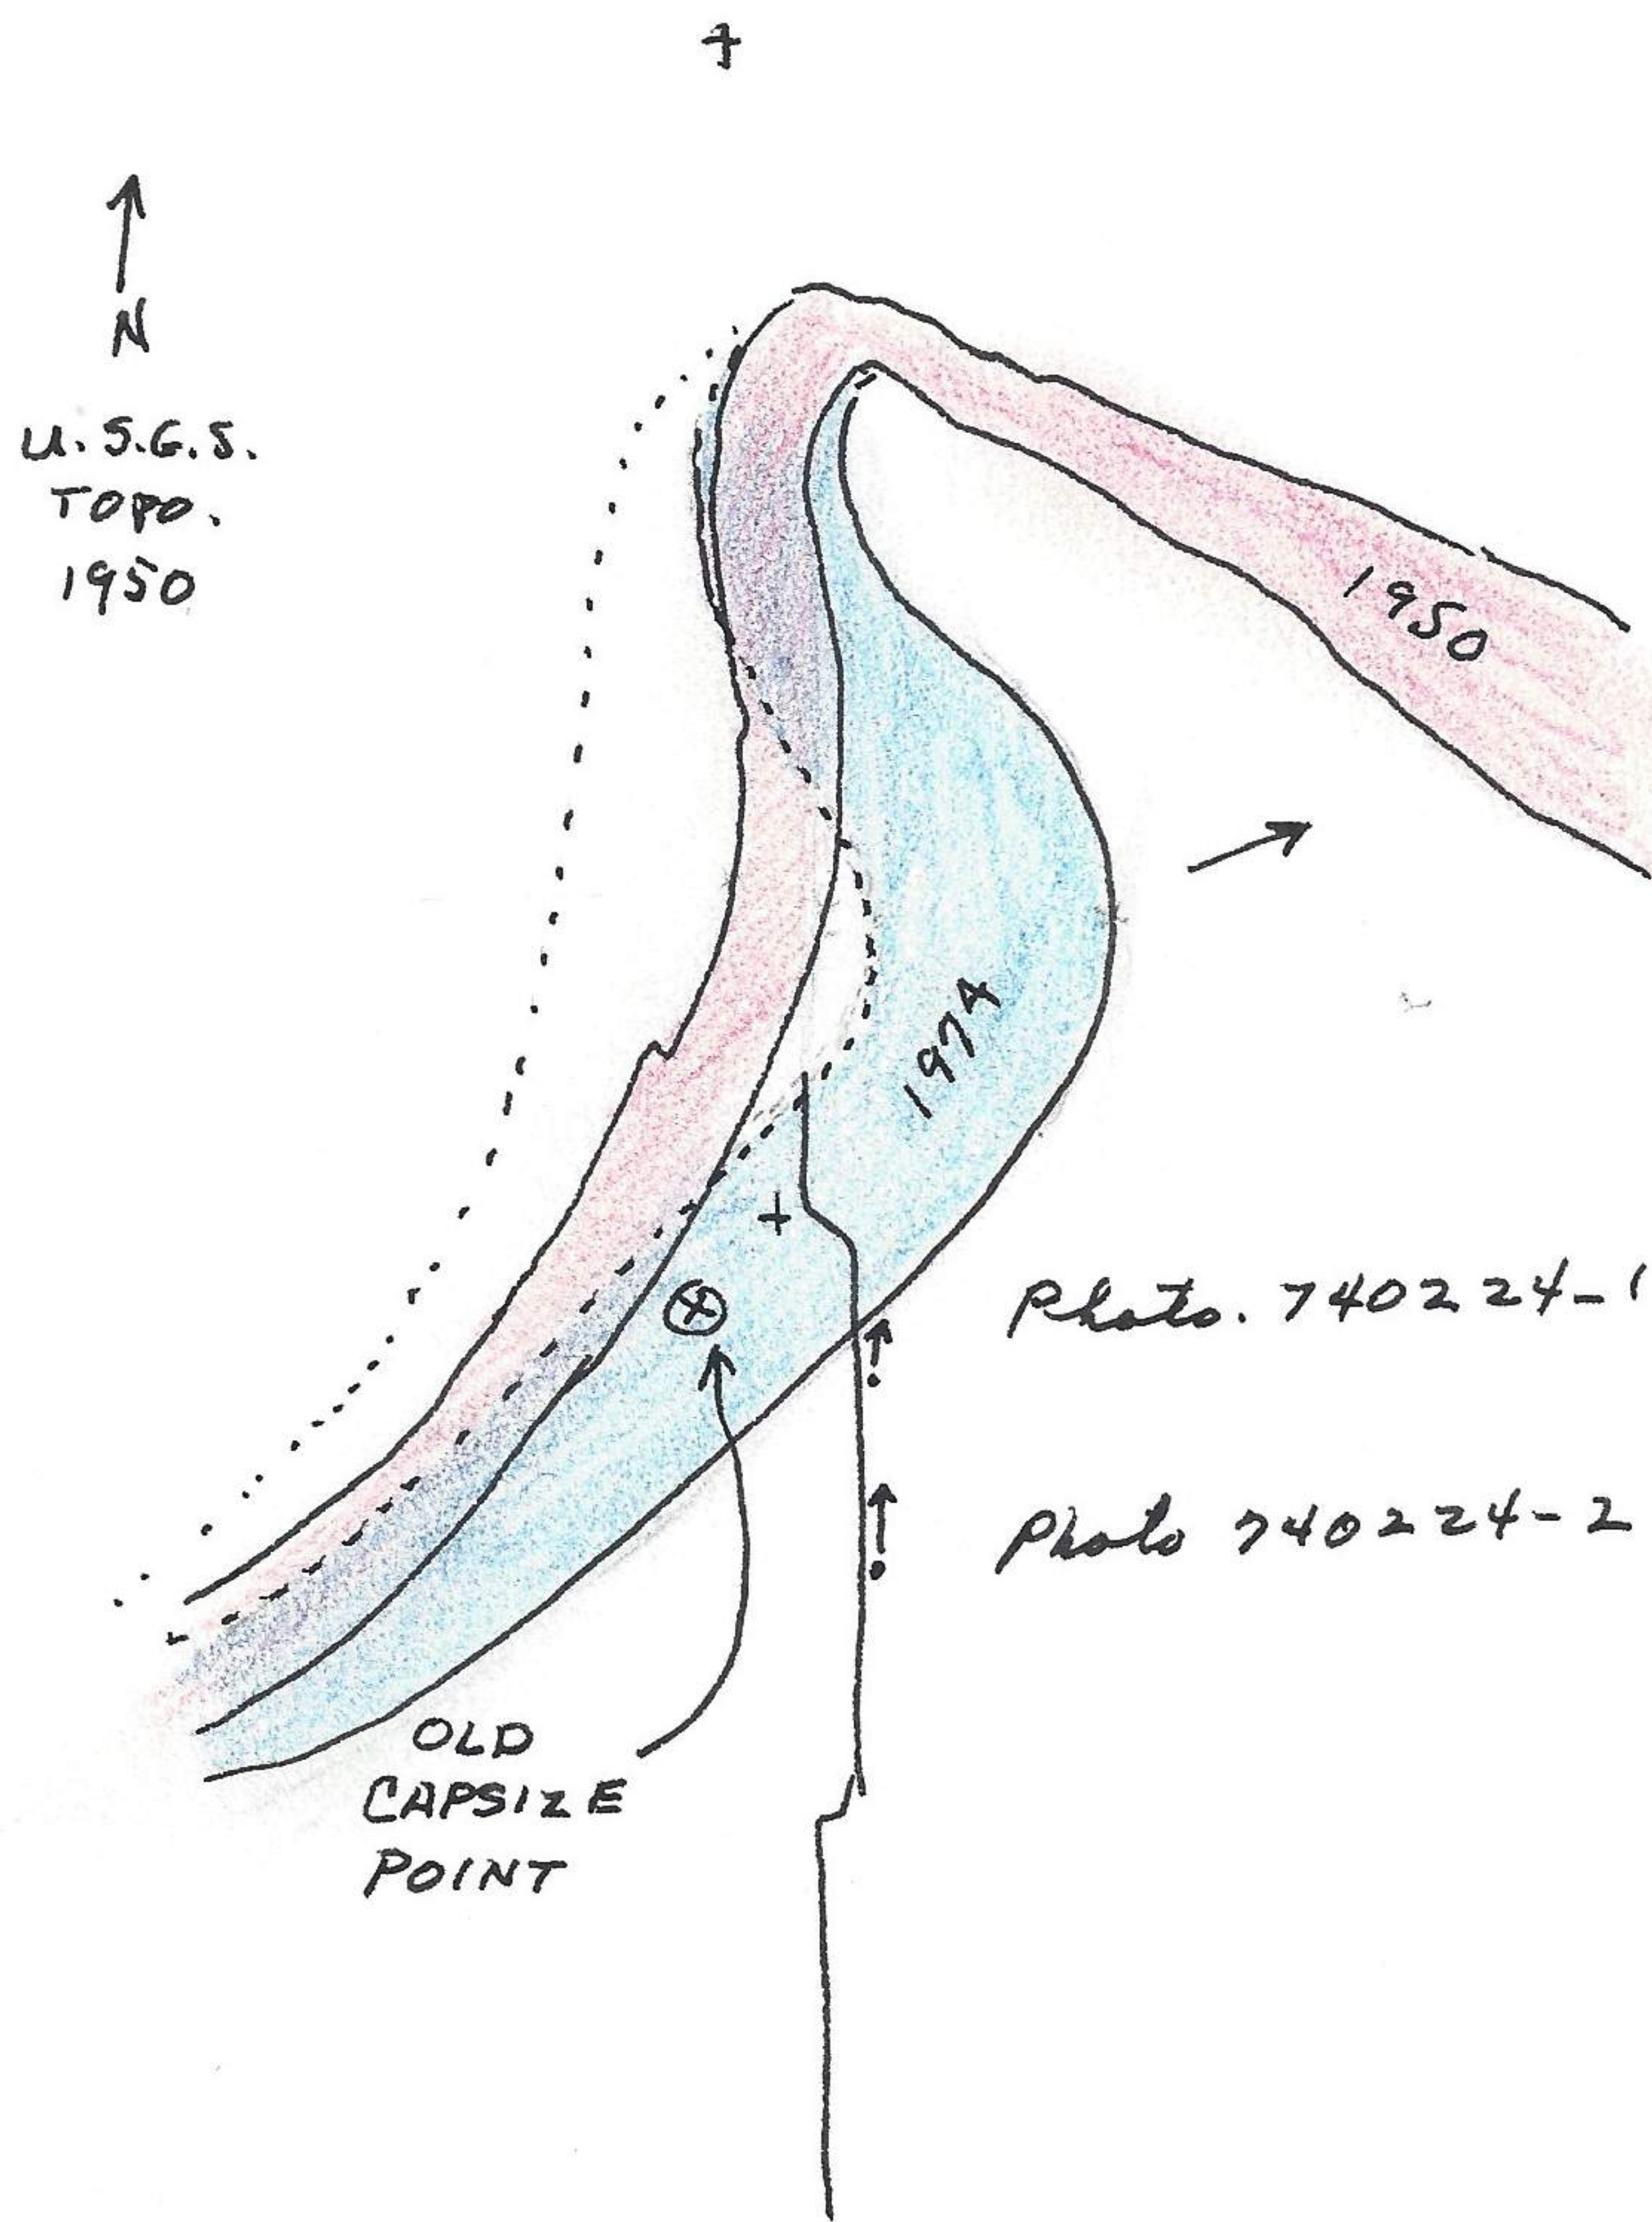
indicated on map:

The sand bar on west side of present river is in area of ^{E side} property prior to 1950. The extension of erosion is being checked by riparian forest but there show some eastward bank erosion.

The fate of this erosion will be the elimination of curve and a break-three to Kaw. There is undeniable evidence of former surface break-three on the present bank profile. Noted 8 ring-billed gulls on and flying up and down river. No other birds observed. Temp. 14° F, W wind, day clear. This stretch of

the river receives the direct influence of northern winds which are the damaging winds and they, along with the present Corp. of Engineers continuous currents may be a factor in the erosion of this bank. Capsize Point was named by me some years ago when the canoe (Annette C and I) capsized here. This old stretch of the river was always the most difficult part of the Kaw to navigate when winds were strong out of the north. Bank swallows traditionally used this curve of the bend for nesting. In the last few years entire colonies of nesting holes have been eliminated from the eroding banks. With increase erosion of these banks the swallows will be placed in jeopardy.
