Lake View, Douglas Co., Kansas
March 5, 1977

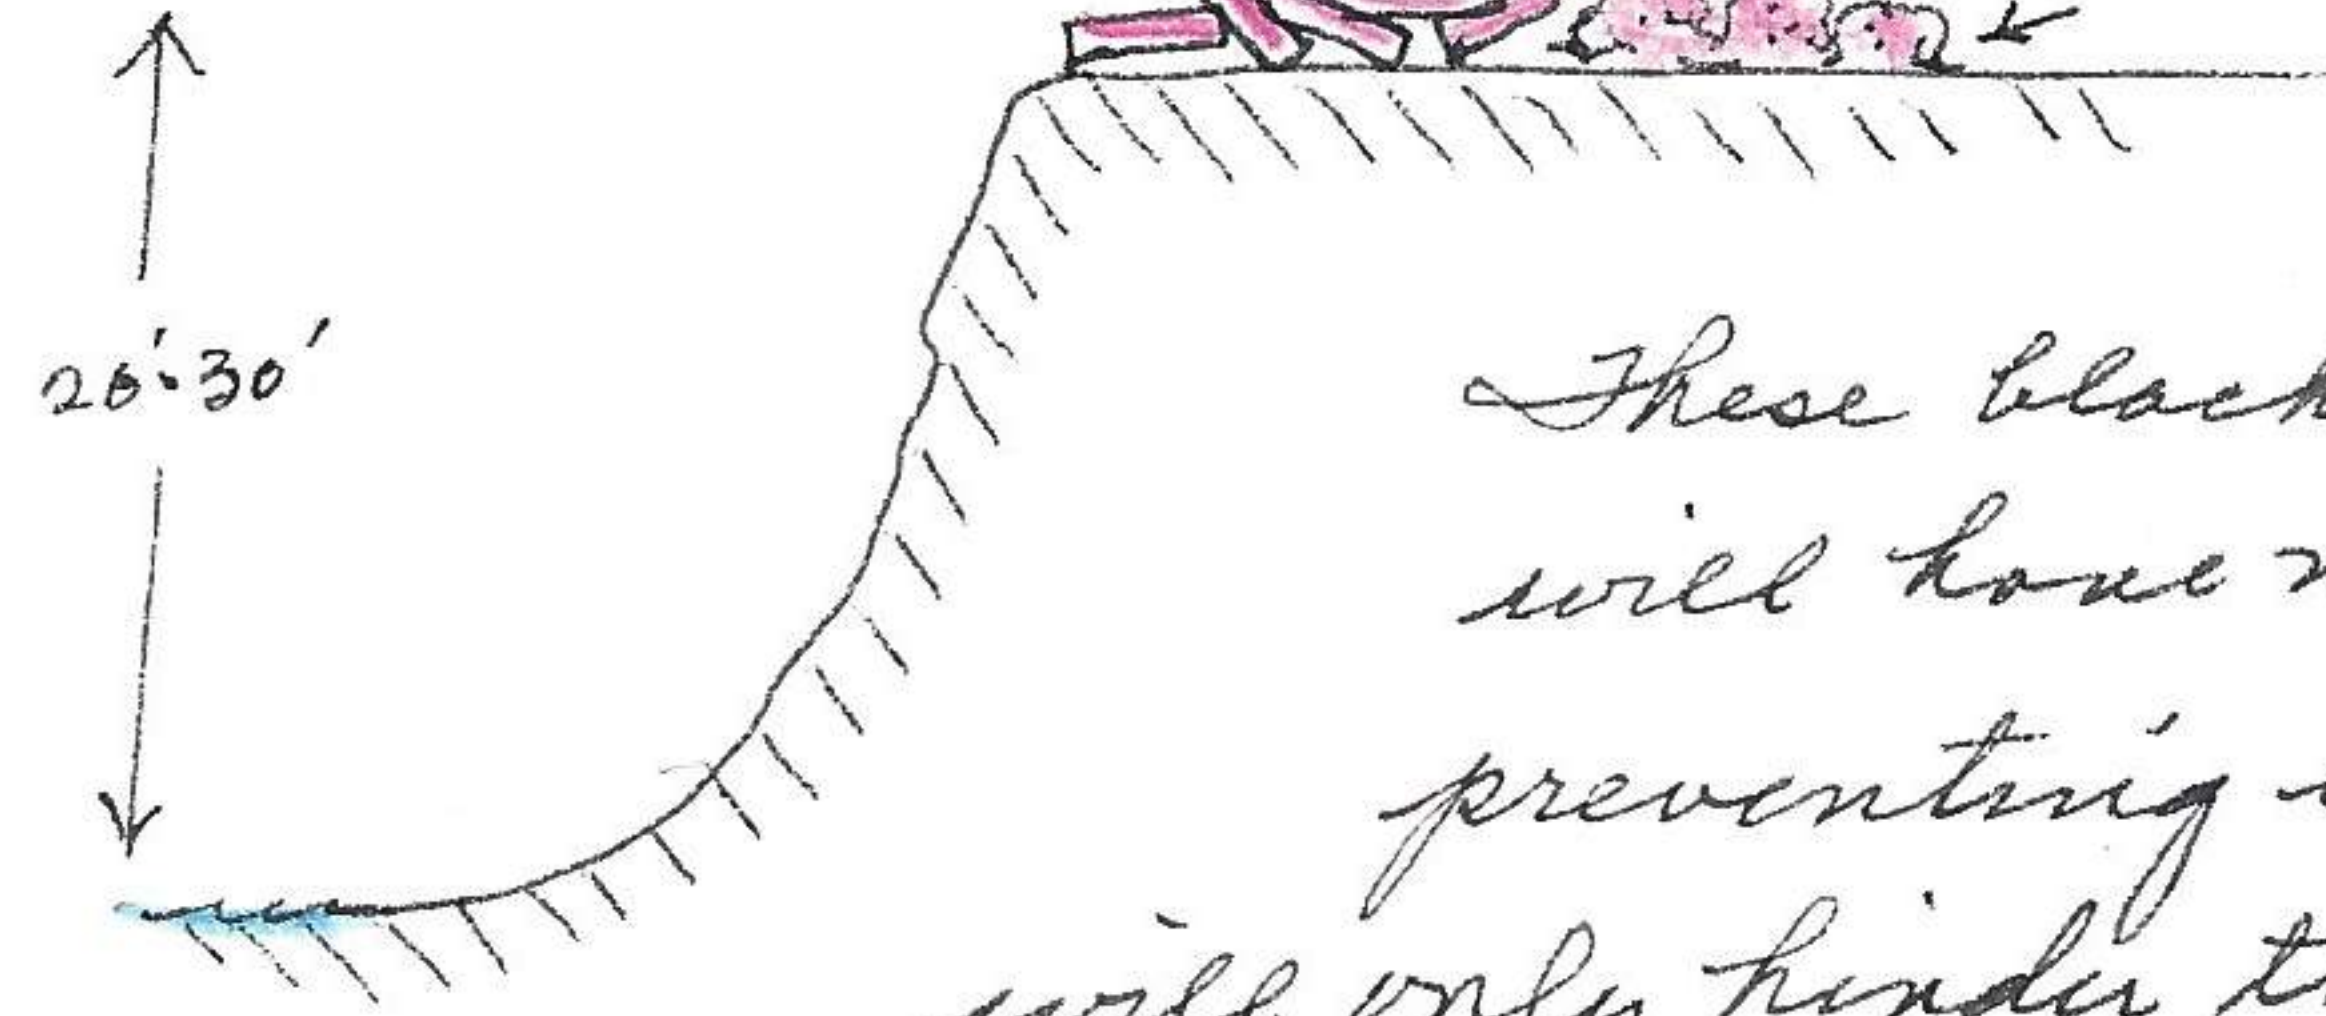
3-6 foot block concrete macadam and other debris

These blocks of cement will have no effect on preventing erosion and will only hinder the preservation of the river bank.

A solid and uninterrupted coating of large boulders along the entire meander curve is the only thing that will stop this erosion.

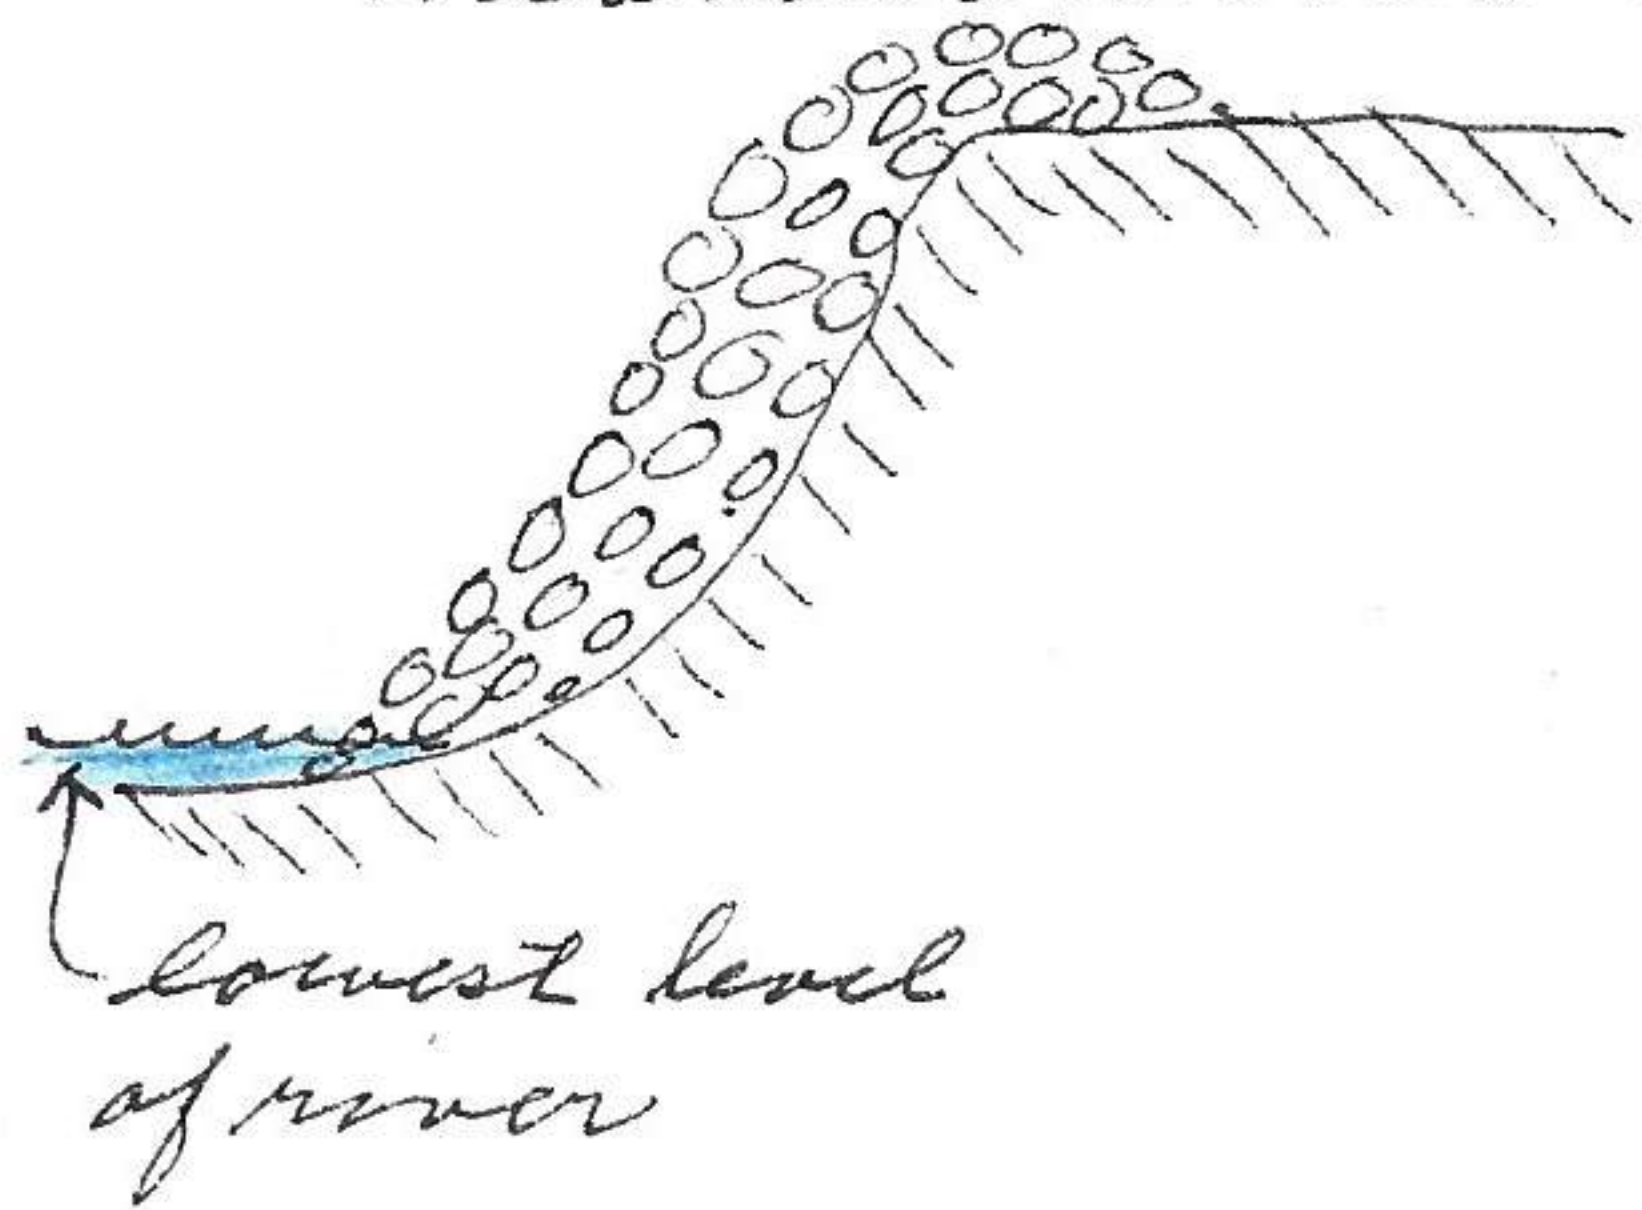
Old cars, rubber tires etc increase the erosion of the river bank. Jetties of rock are soon bypassed and in time they are left as islands in the river as the bank erodes behind them.

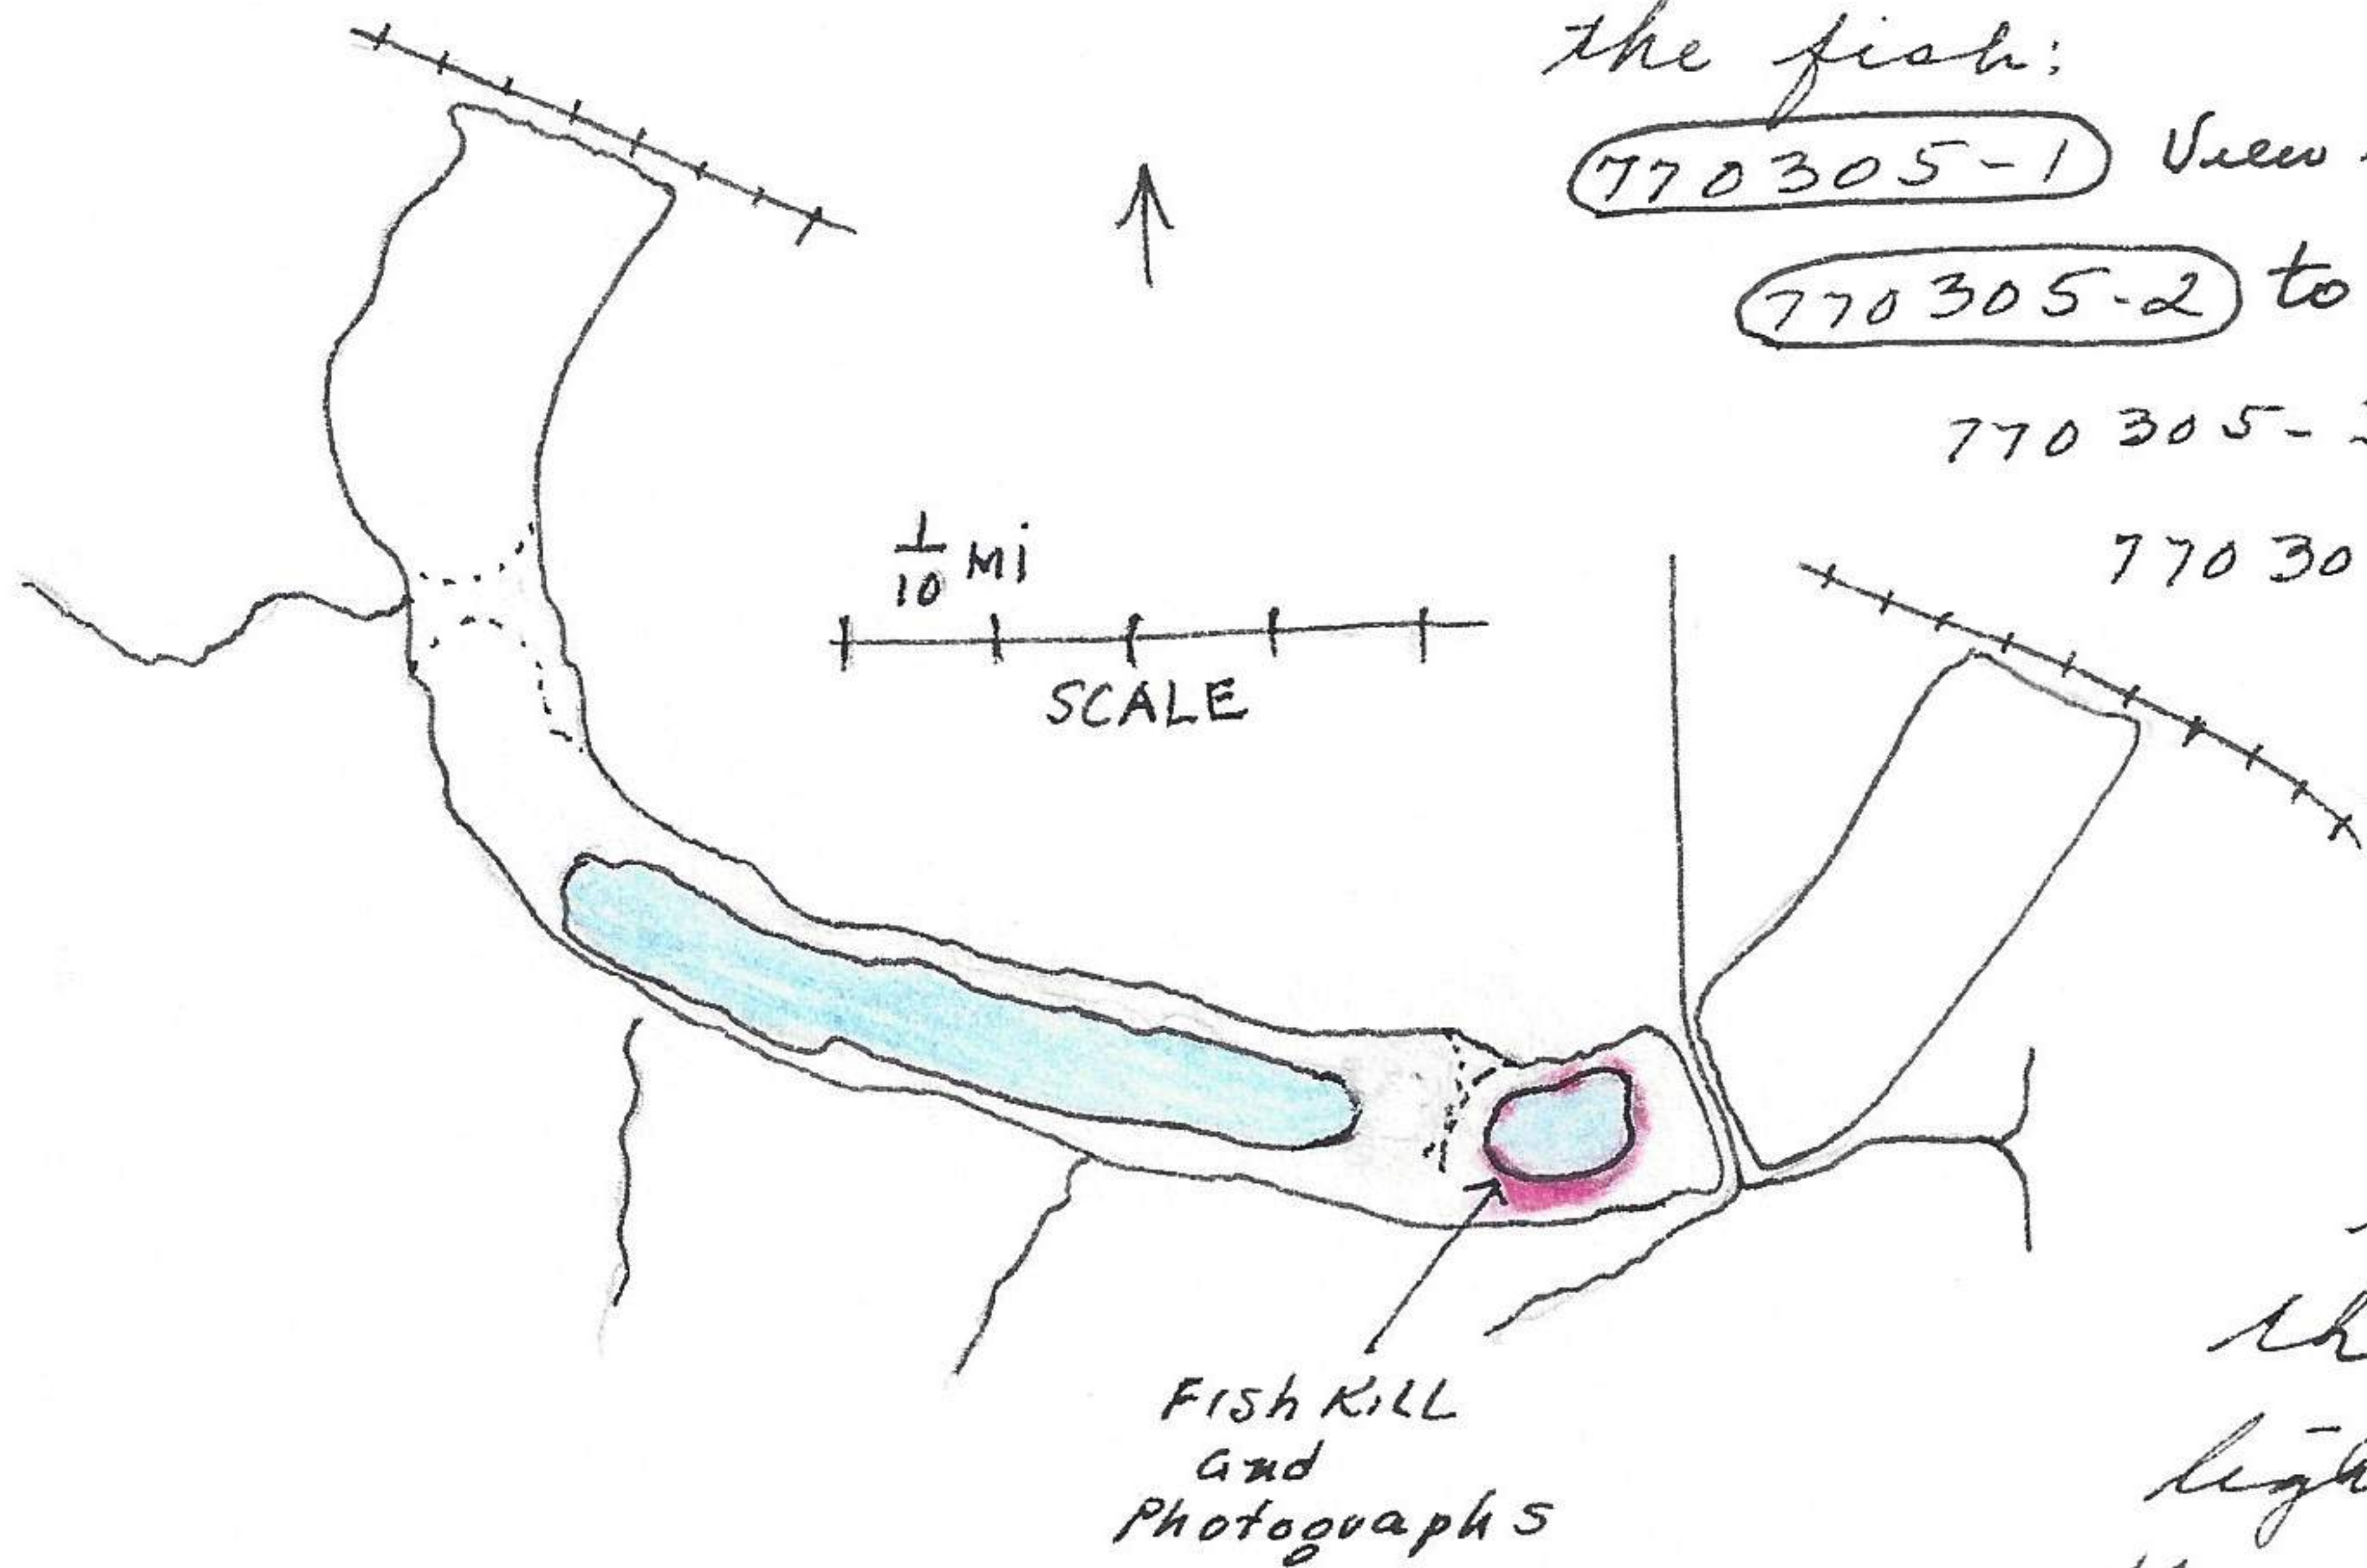
Mary and I made a preliminary check of fish kill at Lake View and made several photographs of the fish:

- (770305-1) View to W from E + N end Lake
- (770305-2) to W from SE corner Lake
- 770305-3 NG
- 770305-4 NG.

kind of fish eating birds. Raccoon tracks, however, were associated with the fish and several of them had been partly consumed. The odor was tolerable at this stage of decomposition because of the cool nights & day.
