661216-257

Kaw River.  
7/10 mi. W and 1 9/10 mi. N Lawrence (old P.O.), Douglas  
Co., Kansas

Dec 16, 1966

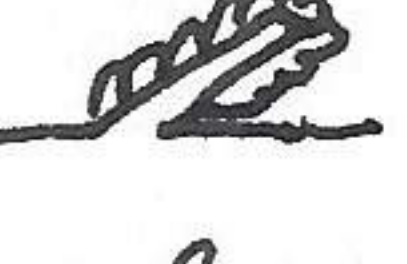
Inspected area of picture 661216-9 taken yesterday. The long parallel stream are gravel covered with a mosslike algal. This algal was collected (no 661217-1) and is                     . It covers, <sup>and stabilizes</sup> pebbles, <sup>grams of sand,</sup> stems or anything that is stable in contrast to sand grains which are continually moving. Stems are coated on all sides

. Pebbles mainly on anterior exposure of their surface

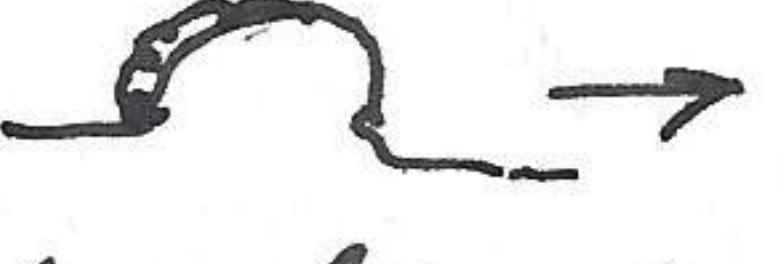
. Between the lines of algae covered rocks and stable soils are tracks of fine sand grains or clay that do not support the plant growth. Some areas are completely covered with the green algae. On more stable attachments the algae grows to 1 inch in length, elsewhere merely covers the pebble. When these lines of algae become dry land because of the lowering of the water they disappear as a green algae. It is possible that they grow only when the water is low and clear and may not grow when water is high and supporting sediment. Ice plates push the algae into ridges below and above the surface of the water thus:
