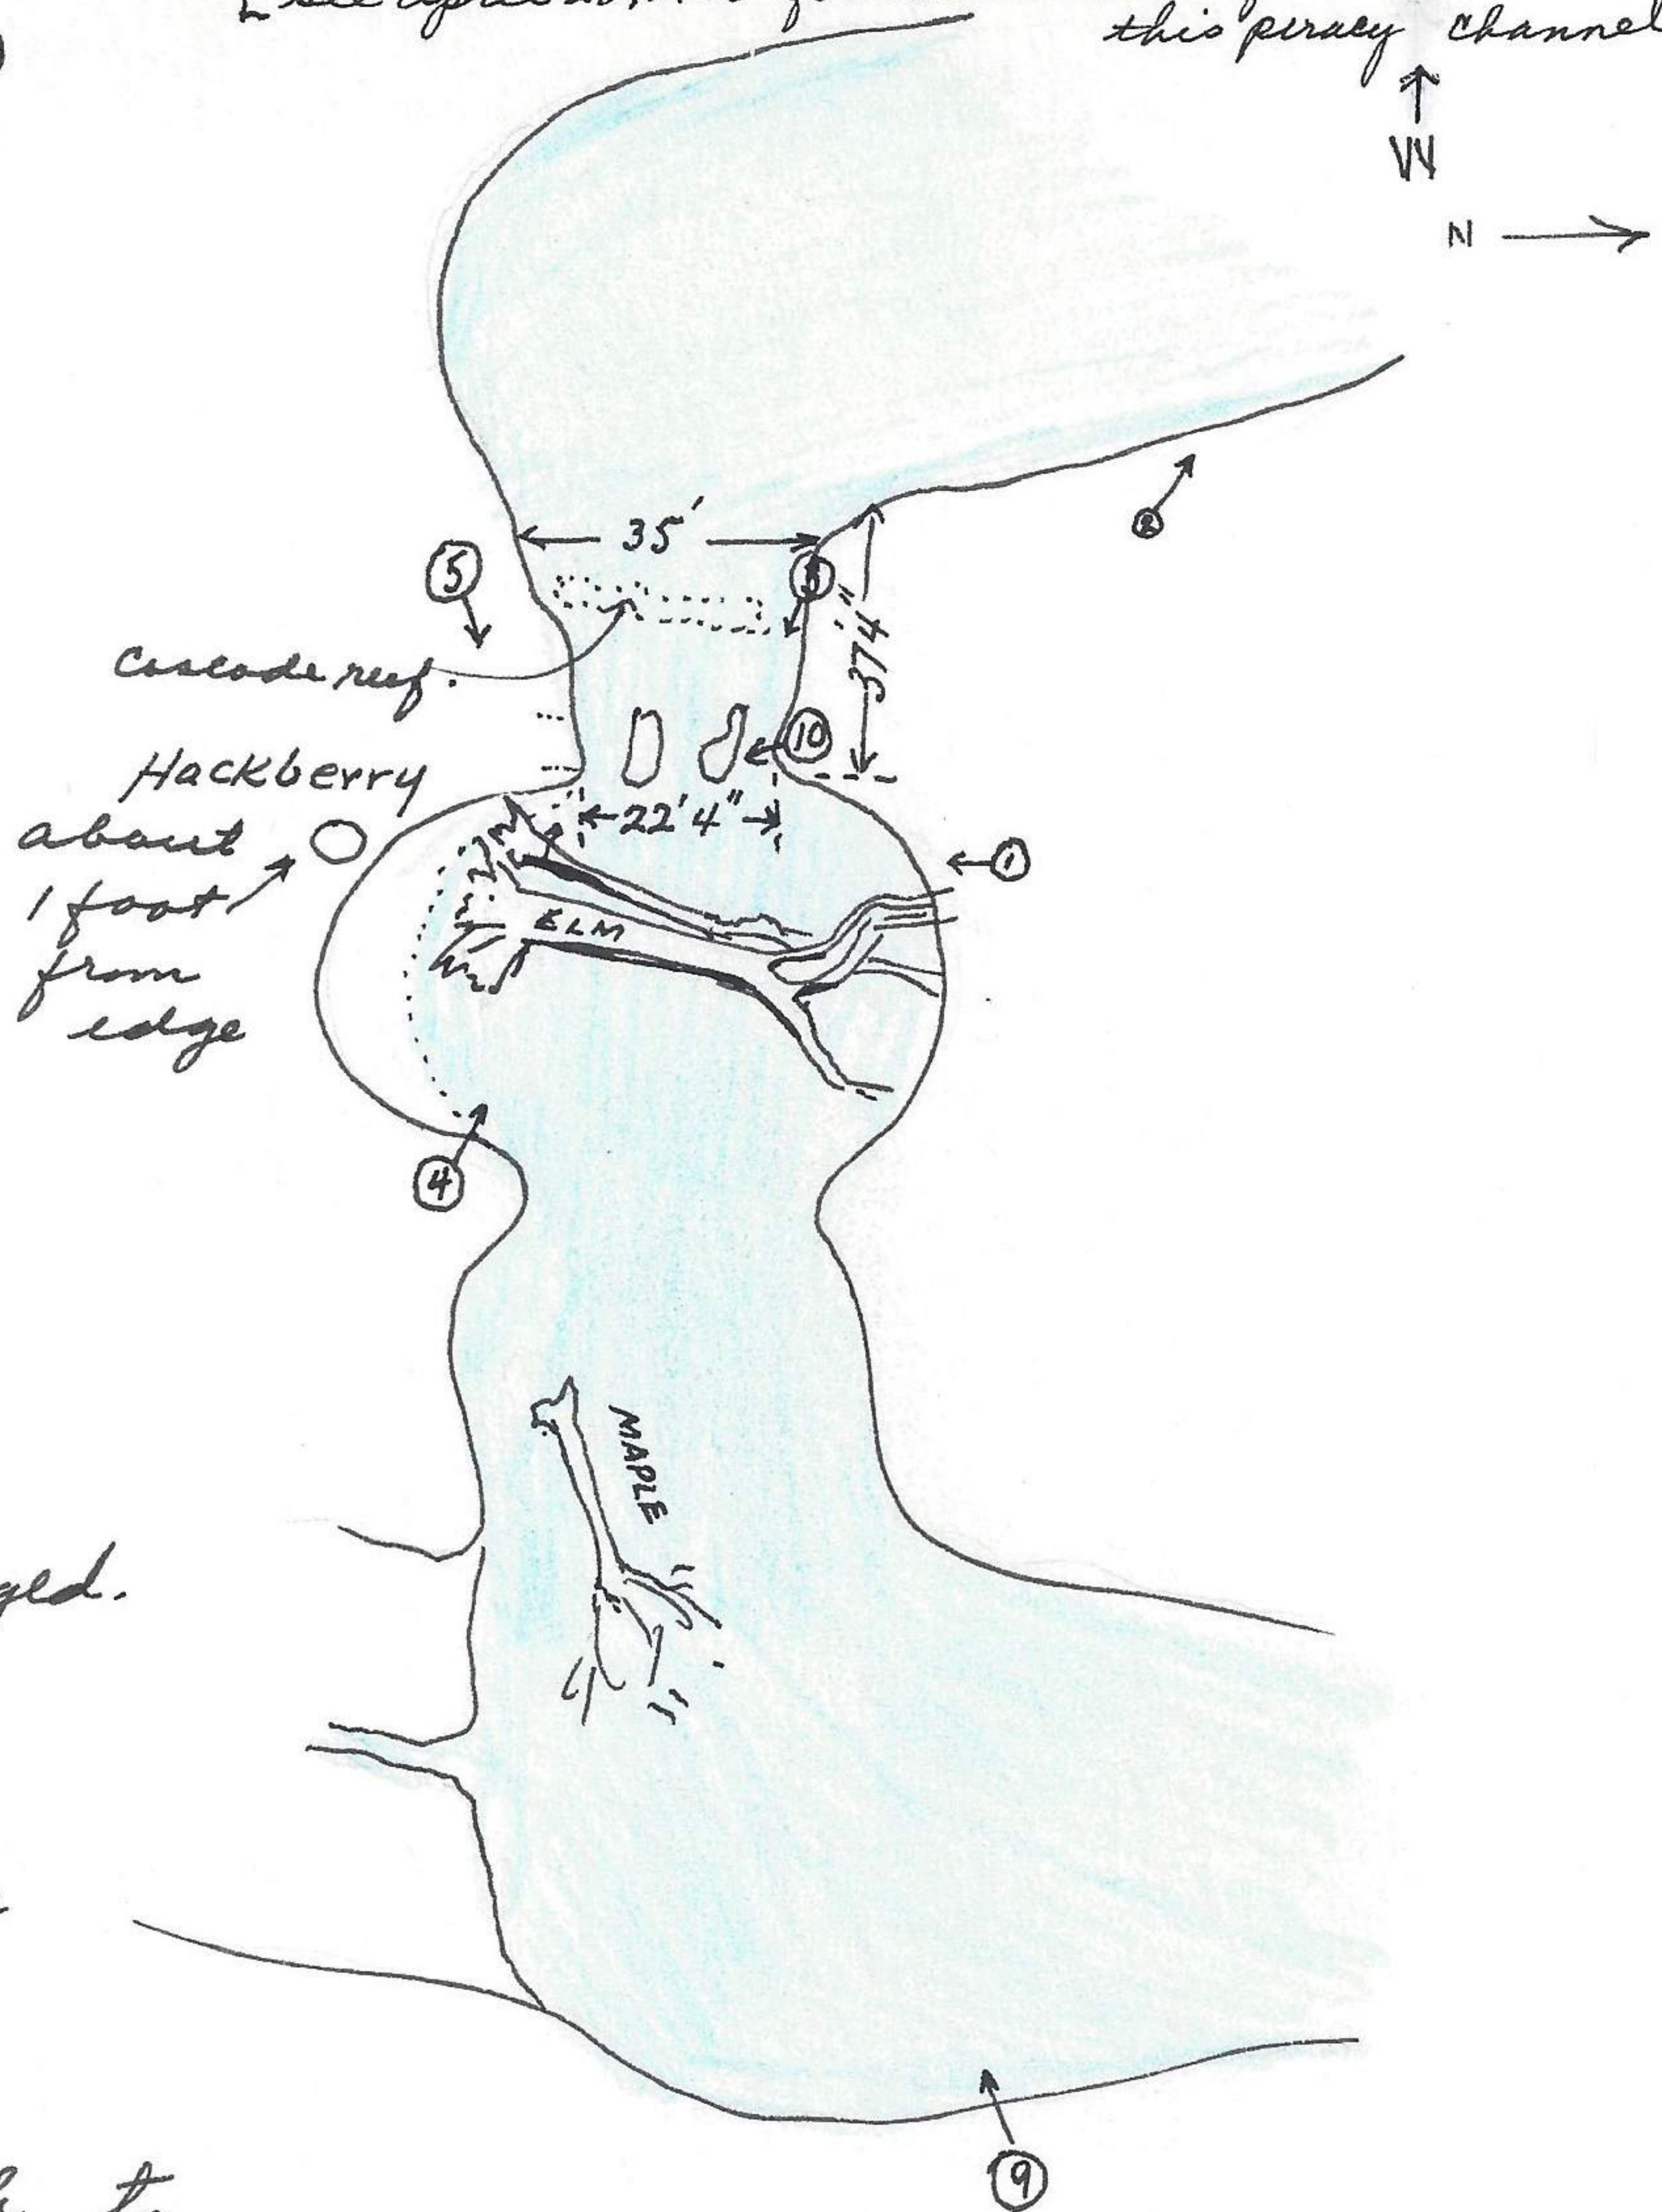
The first circular basin below falls is much as this spring in April (28th) but S side has soil slip increase from the elm displacement. There is less water now than in spring and edge of cascades exposed. These islands show channel or tunnel formation of circular formation. Crayfish may have made these channel and then water enlarged. A reef above cascade can be navigated with knee boats. The maple tree that was standing in April is now down.

[see April 28, 1968 for addition information on this piracy channel]

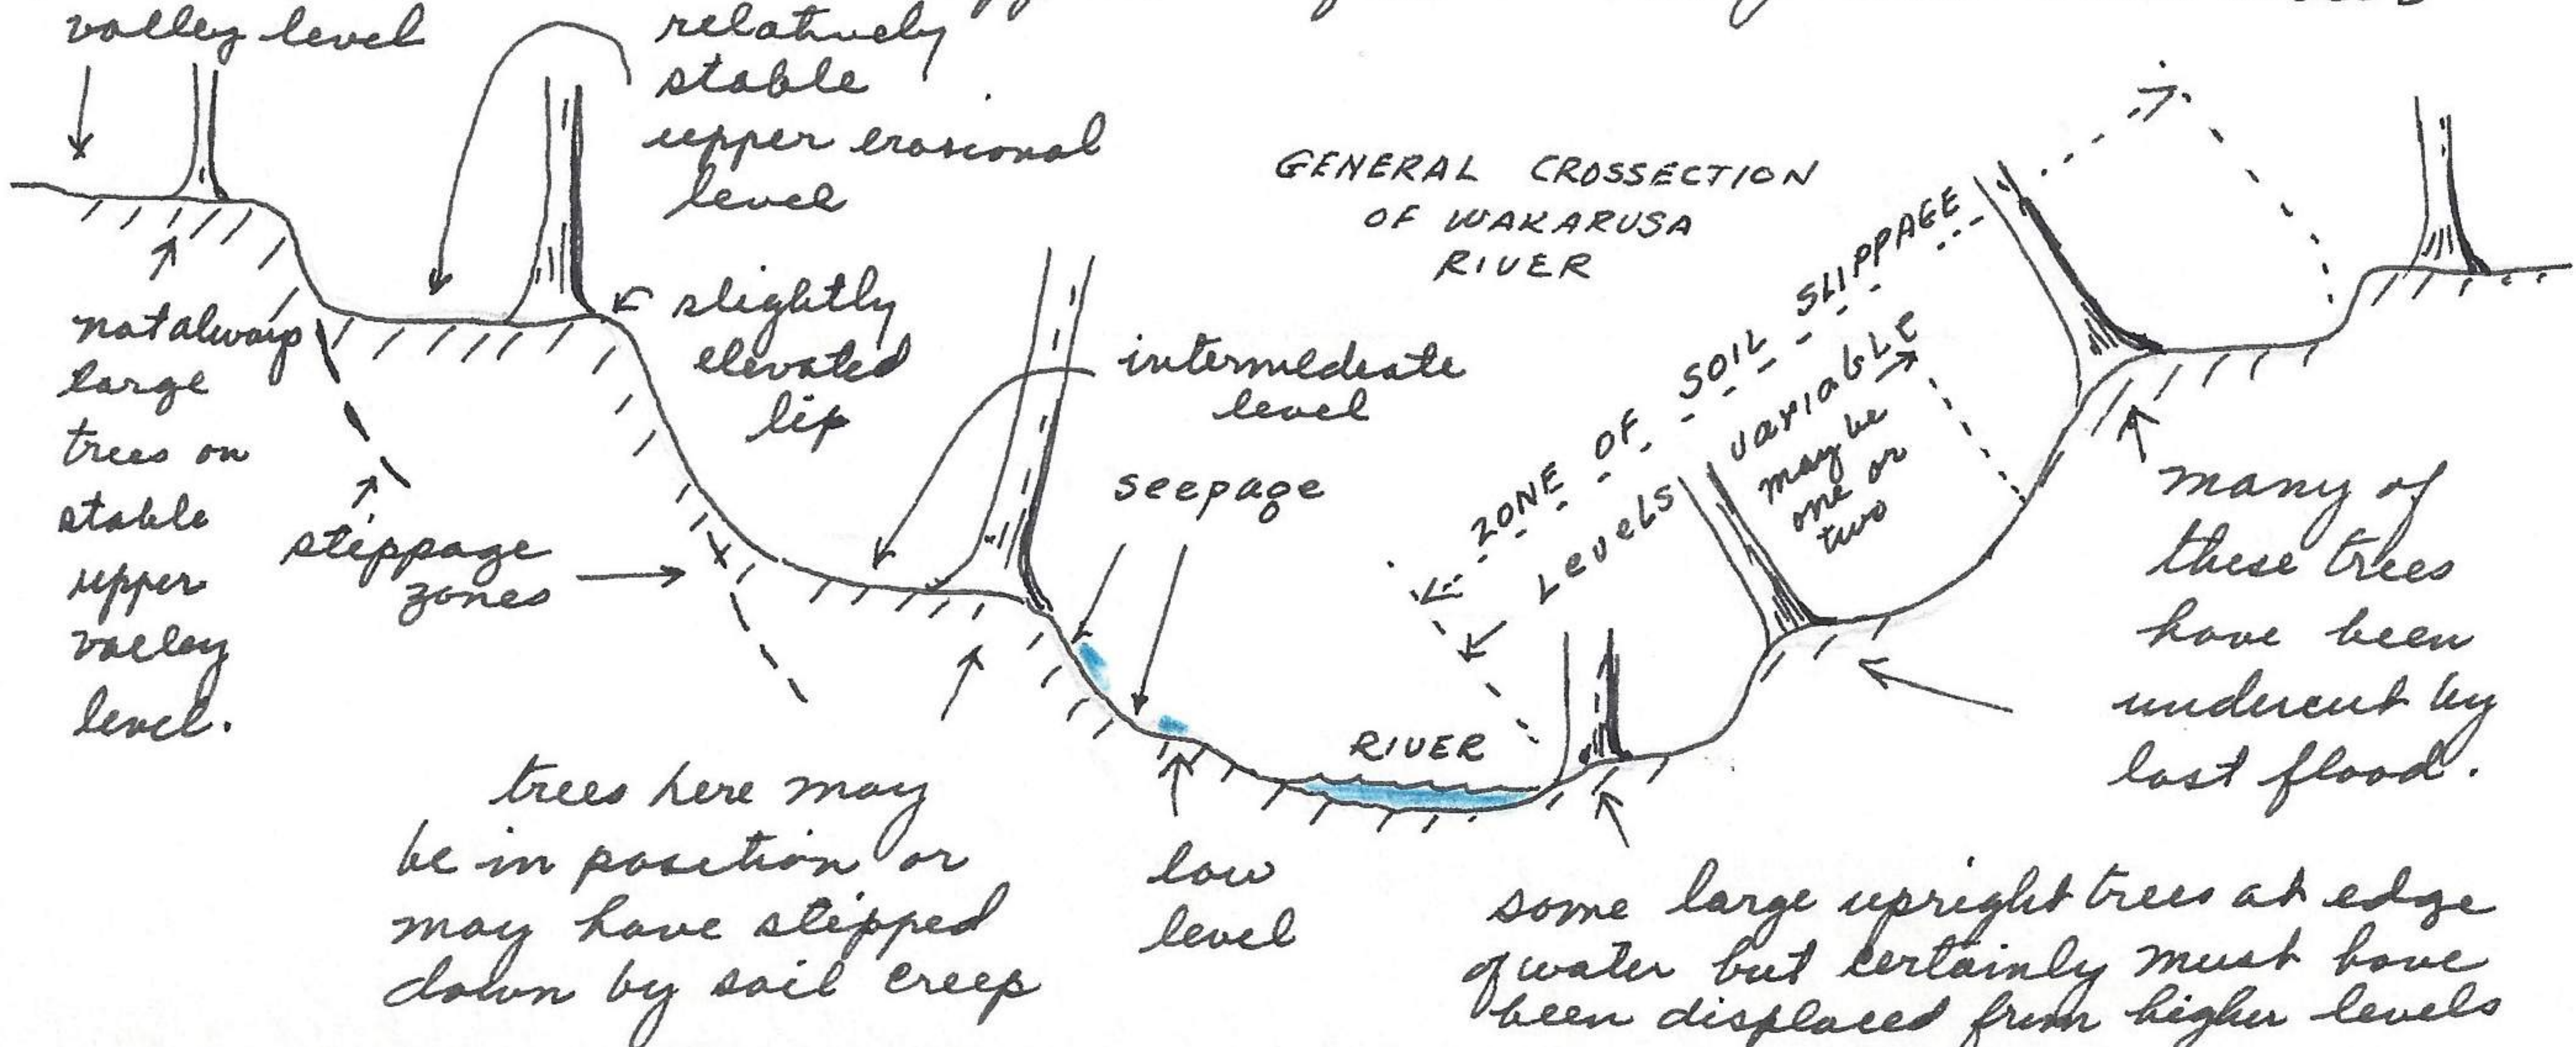
The water is low enough to permit seepage drainage from abandoned limb of old bar to enter as a narrow 1 1/2 foot channel. Mud in this old drainage channel, except 2 crossings, is too deep for crossing and when attempted ones become secured in mud and boats cannot be extracted except to step out of them and then build up platform to extract boats. The barrier across entrance to old channel is now approx. 3 feet above present water level & valley level.
