Lake View, Douglas Co., Kansas
 Sept 12, 1976

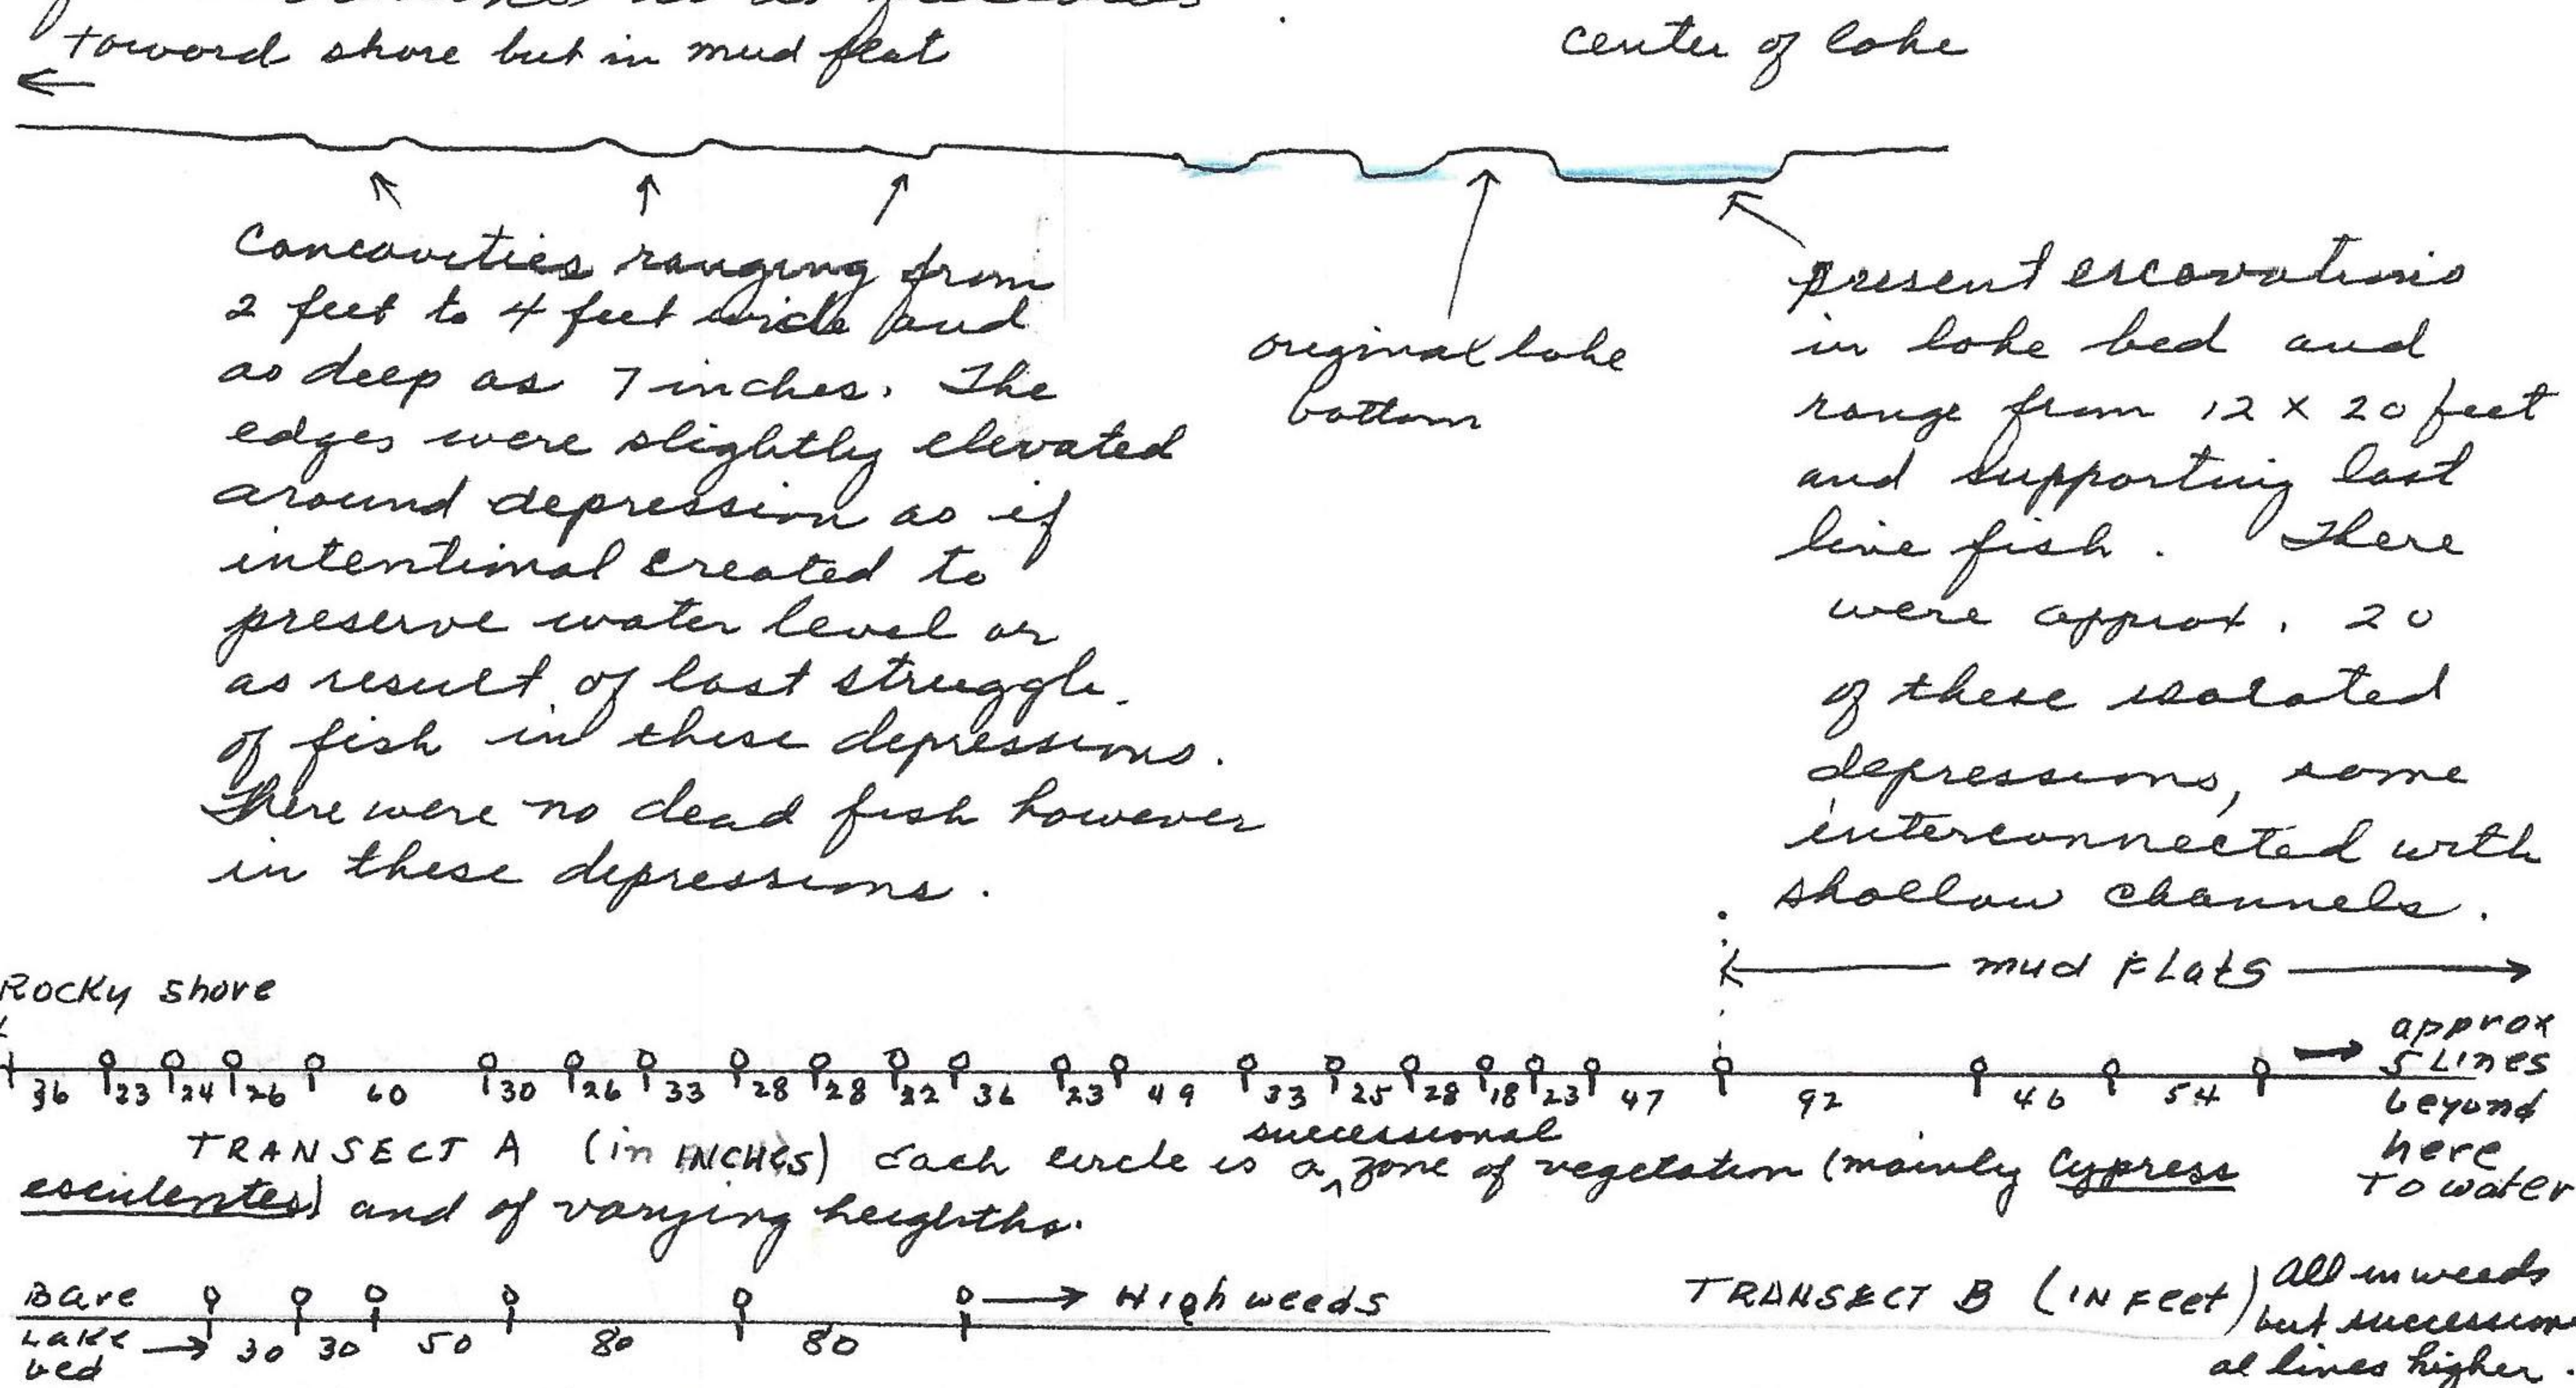
Checked low water at Lake View (NW end). The present level is as indicated in map below showing occurrence of water, mud flats without vegetation, successional zone of invading weeds and in NE section lotus stands.

Bluegill, green sunfish, ^{Croppie} and other kinds were present but the gizzard shad was dominant. There were approx. 40 catfish, the largest was 500 mm in standard length. Some of these were being worked on by flies. There was approx. the same number of carp. The water pools were excavated and were deeper than the height of the few carp & catfish still ^{above} the water but perhaps not over 2 dozen or so. The profile of excavations is as follows
