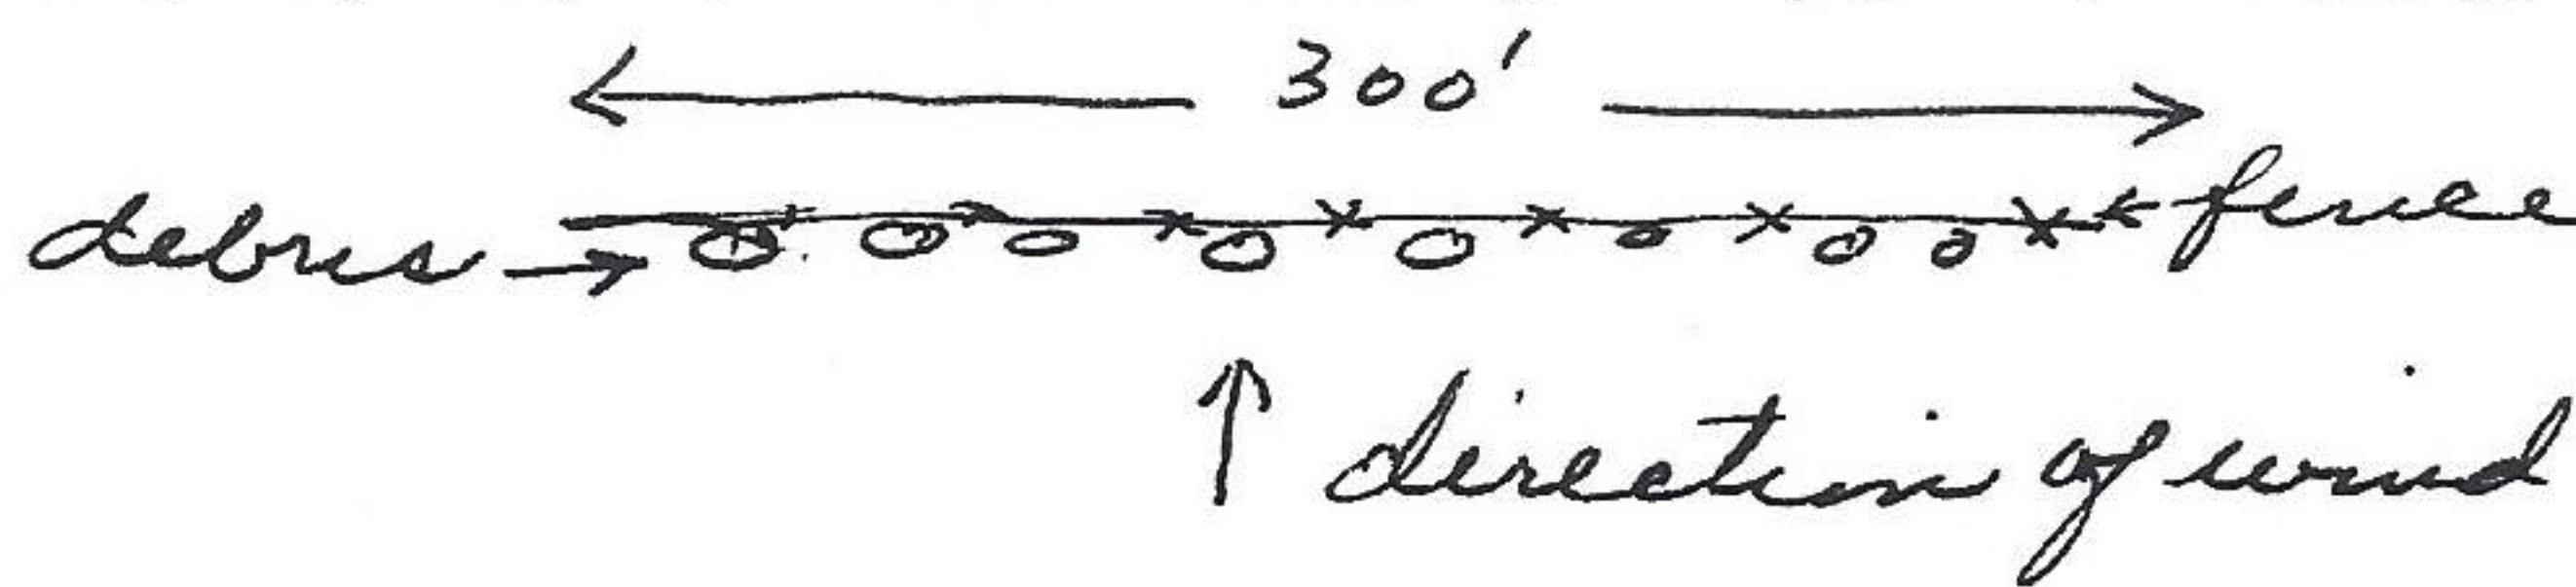
direction of the wind (or it could have been the initial wind, was to the north. High trees seem to be affected by winds of a different direction than ground or surface winds which are in the direction of the general movement of the tornado. For instance debris collects on fence lines that are at 90° to the direction of the tornado.

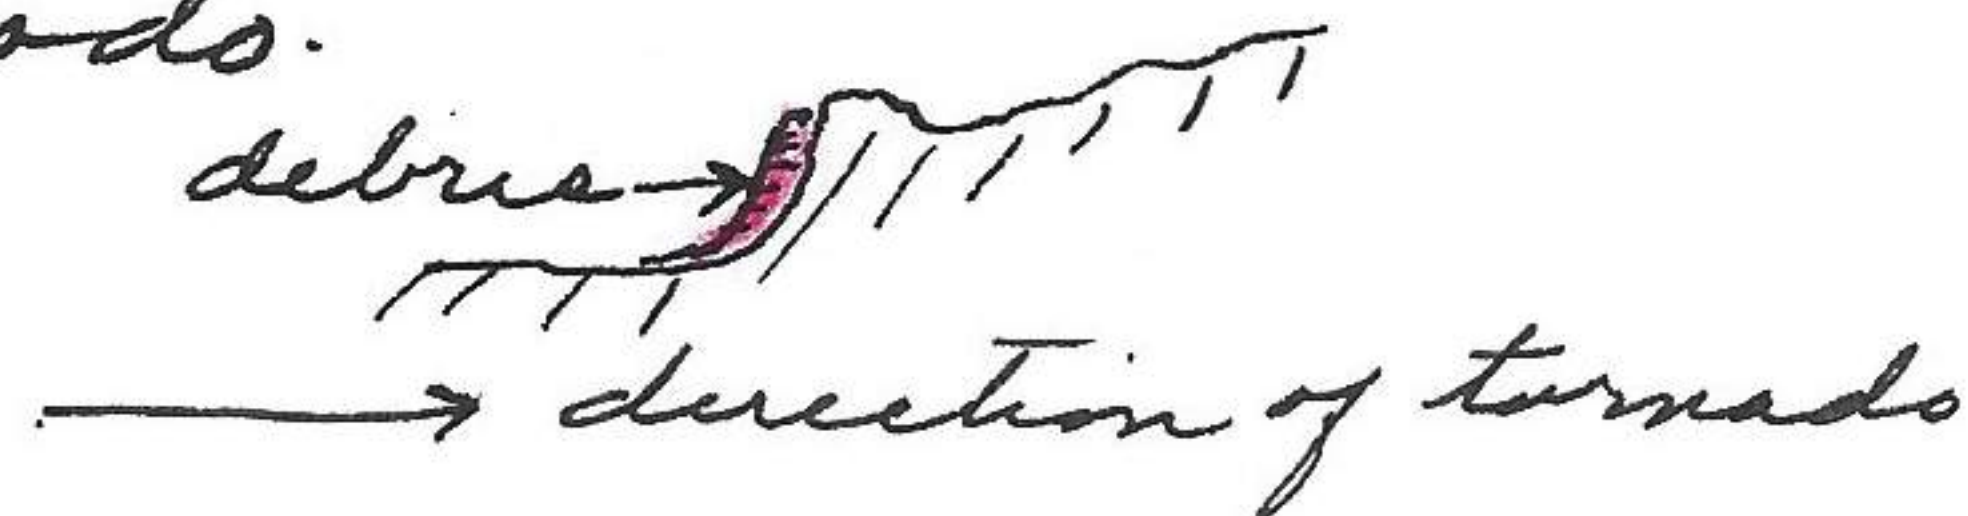
The area of debris, in several instances was as much as 200-300 feet. Rock ledges or rock fences were plastered with debris (water soaked grasses, weeds, and other vegetation in the direction of the tornado.

Trees, however, generally fall at right angles to the direction of tornado.

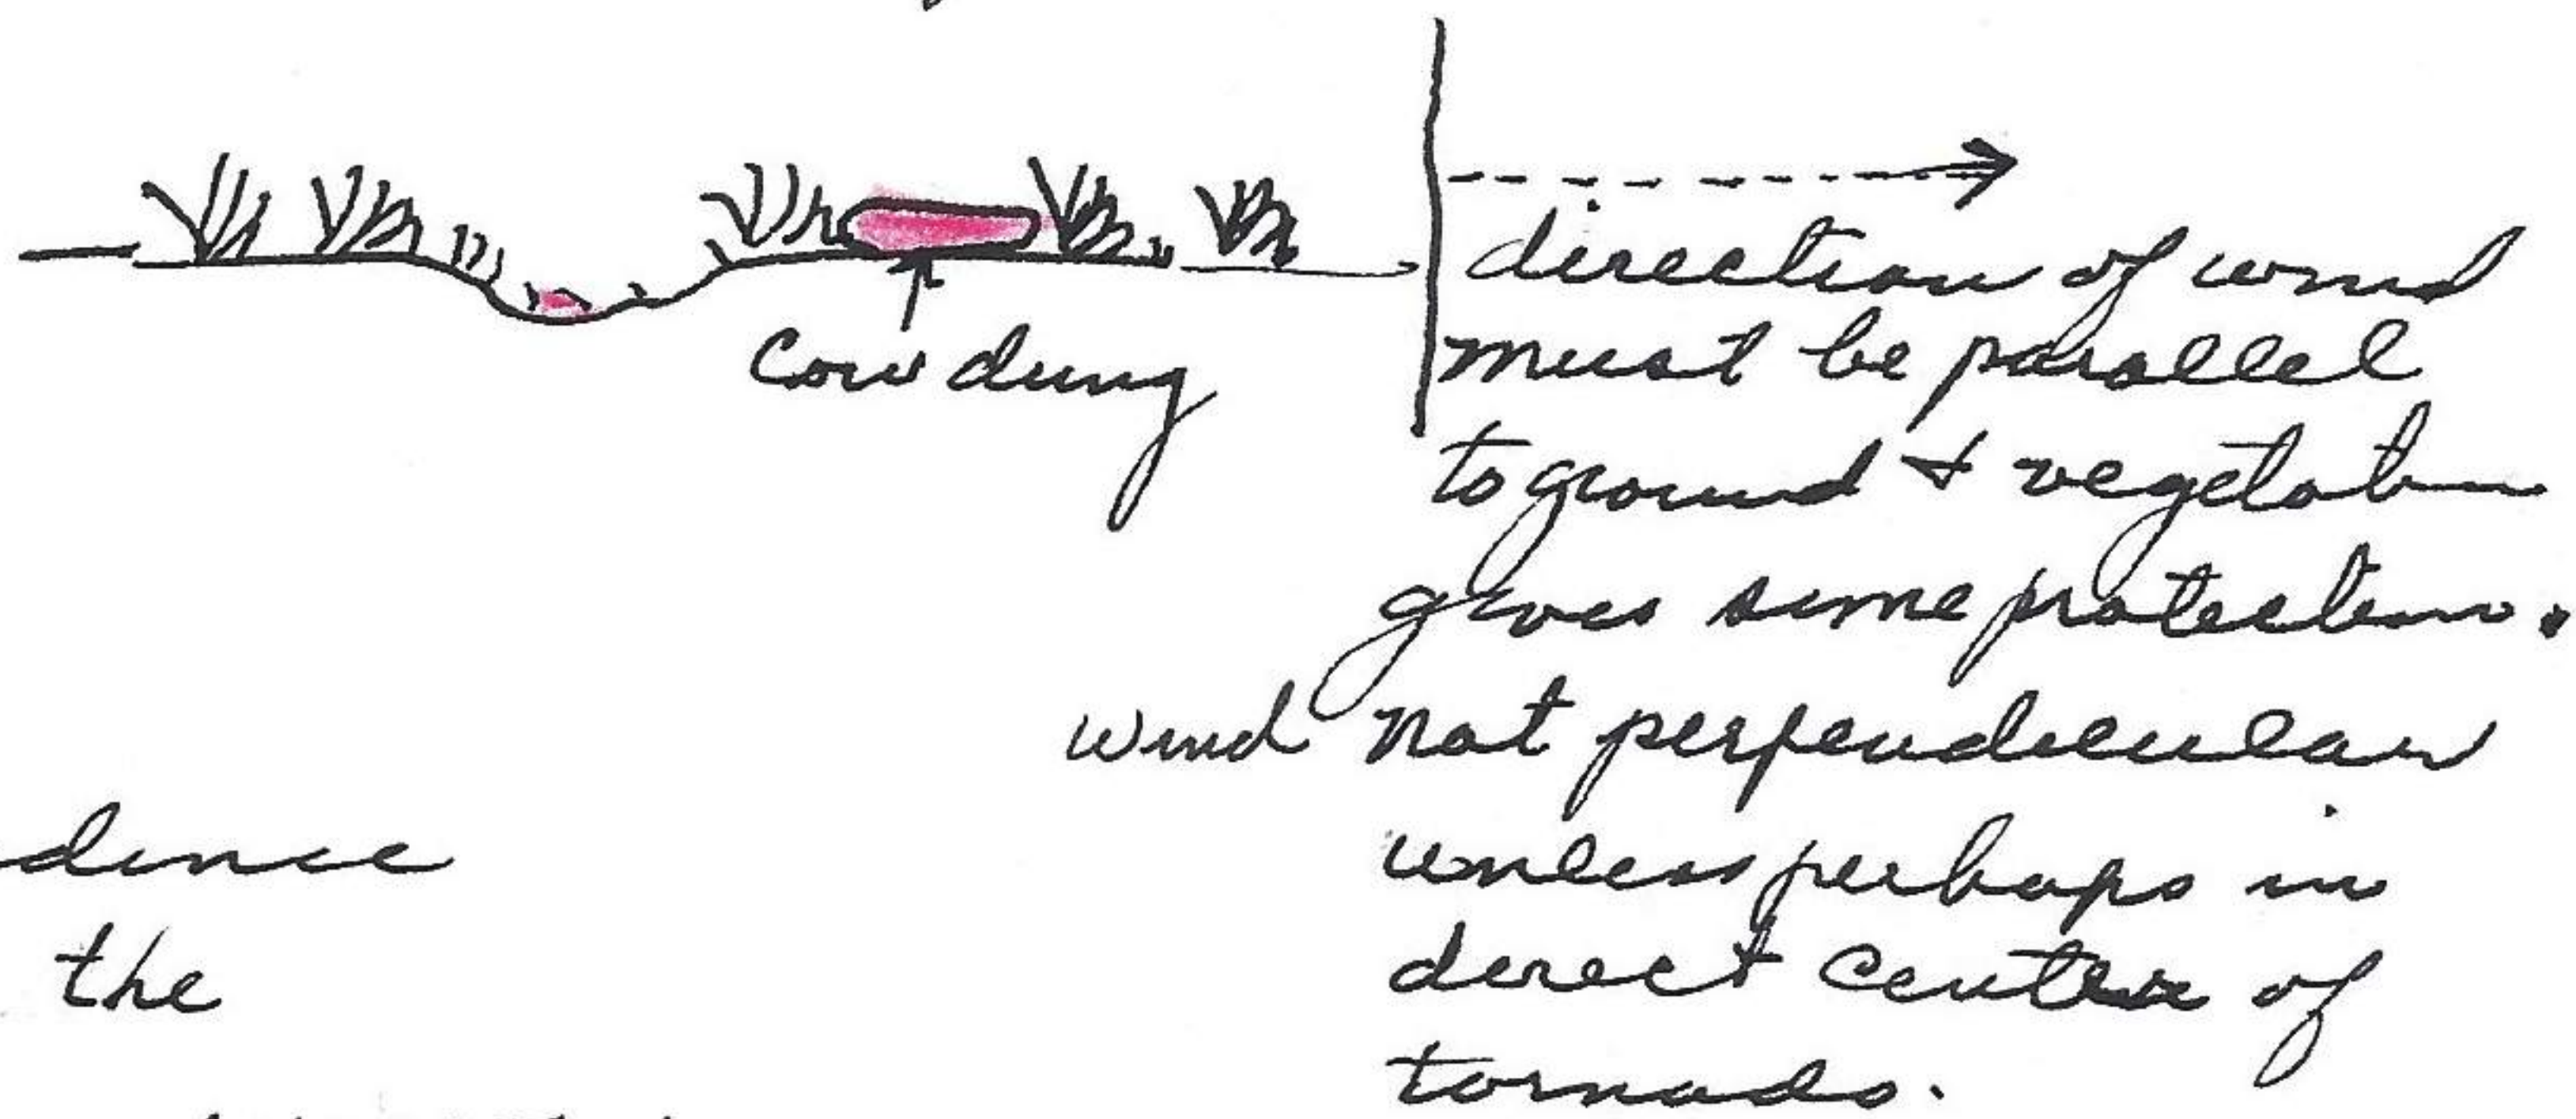
In the field where the large trees were uprooted, noted that cow dung on ground in short grasses were not disturbed and small branches and debris in shallow depressions were also in original position.

Some rocks of rock fences were blown 3 or 4 feet beyond fence in direction of tornado.

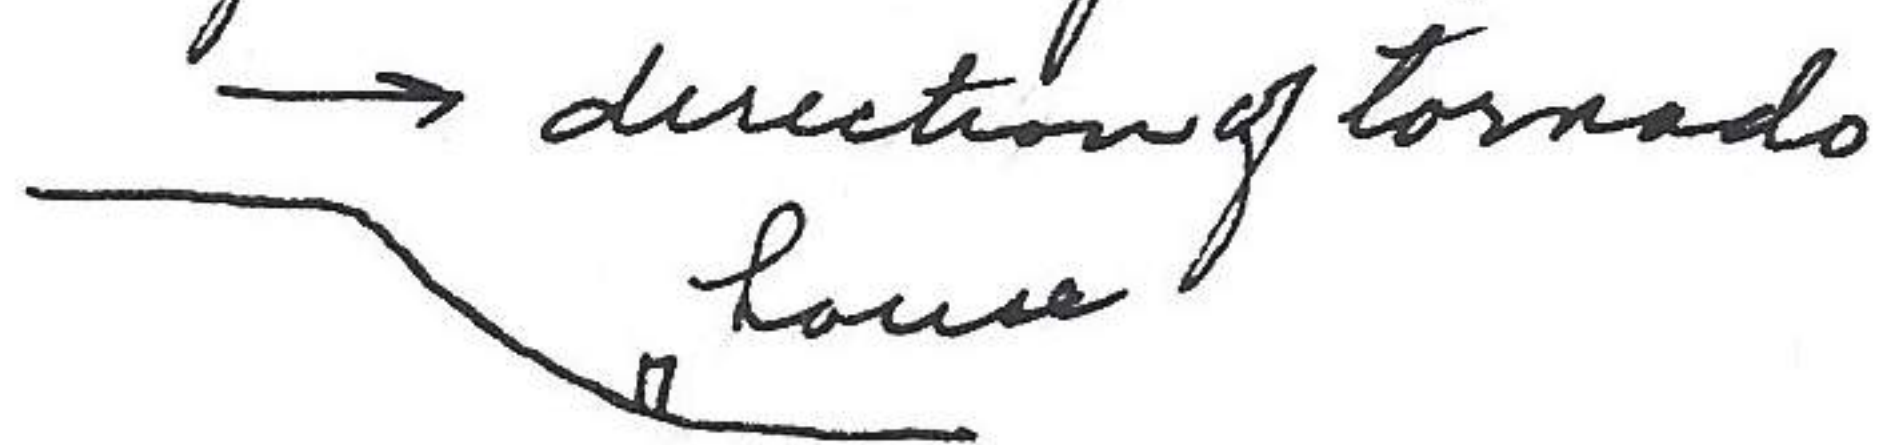
This home was completely demolished and lumber scattered in all direction. An 84

year old occupant was injured and found outside of house. The tree fell in usual direction but the roof of the house was blown from house in direction of the tornado. The metal roof of garage was 200-300 feet away and in same direction from the garage as the direction of the tree. This house is on the N side of the valley slope and at the base or valley level.
