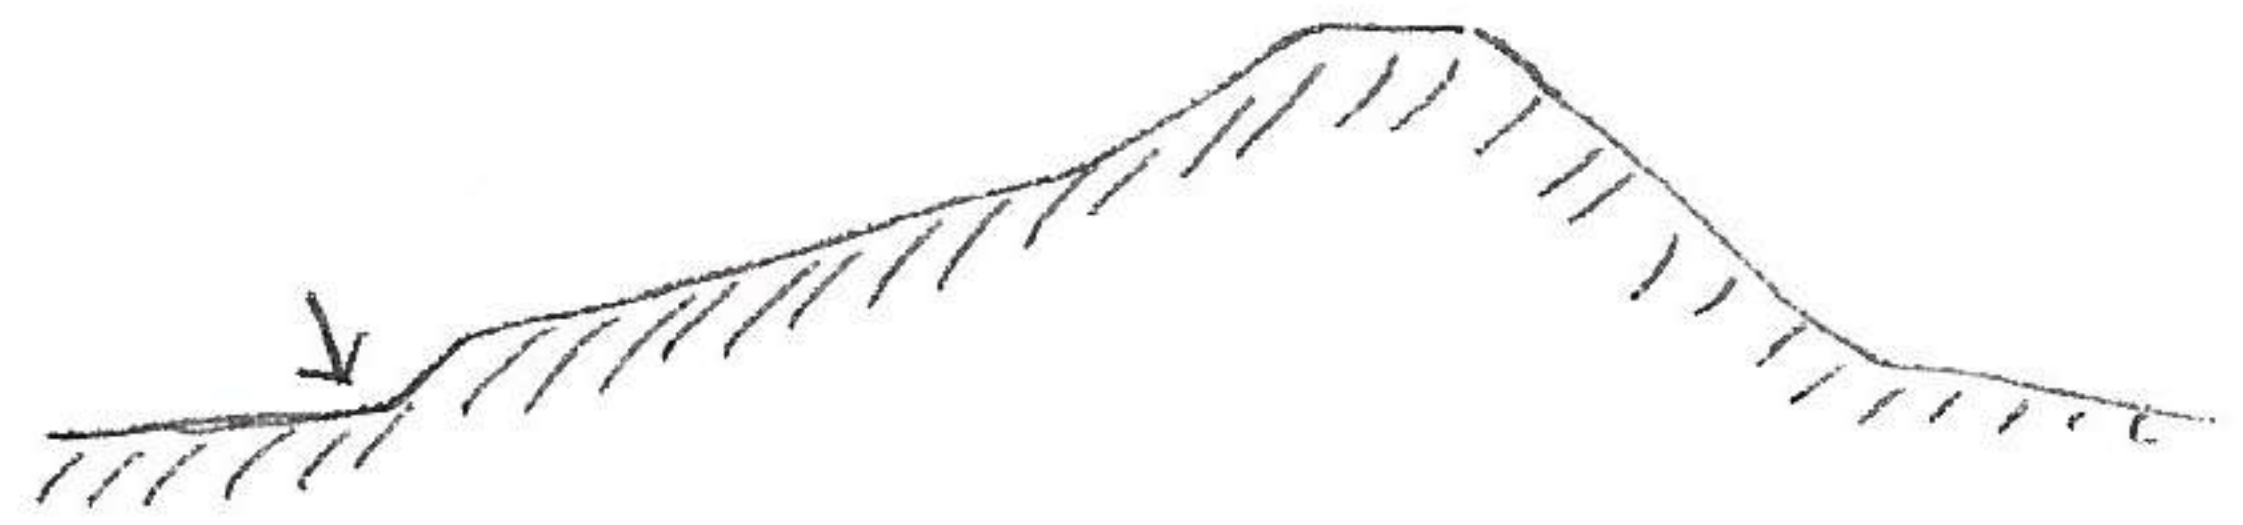
The route along W side of base of dam indicated use by raccoons (10 sets of tracks in thoroughfare, 2 or 3 sets of coyote tracks.

The raccoons were feeding on crayfish and were excavating them in shallow soils at the base of the dam from water edge to at least 2 feet landward. The rocky soil of dam excavations permitted only shallow penetration by the crayfish. About 1 excavation per 20' was average along the base of dam, especially on W end, where shallow ponds butted against the dam proper. Farther N addition soils + clay had been placed against the dam slope. Microtine trails (probably both *Microtus* + *Sigmodon*) occupied the weedy areas, grasses + weeds of old pond floors and onto the sparse weedy slopes of the dam for at least 5 feet, maybe higher. Only birds observed along entire route were 3 song sparrows and 8 tree sparrows. There were no birds utilizing the newly created rock slopes of the dam although I had wondered if the leucosticte might use these slopes. Rock doves and English sparrows were using the outlet gates. There was a decided increase in numbers of coyote tracks near the water gates and the only place along the route where 2 cottontails were flushed.
