Check The Bee, a Grand Banks boat with Stewart Marshall.

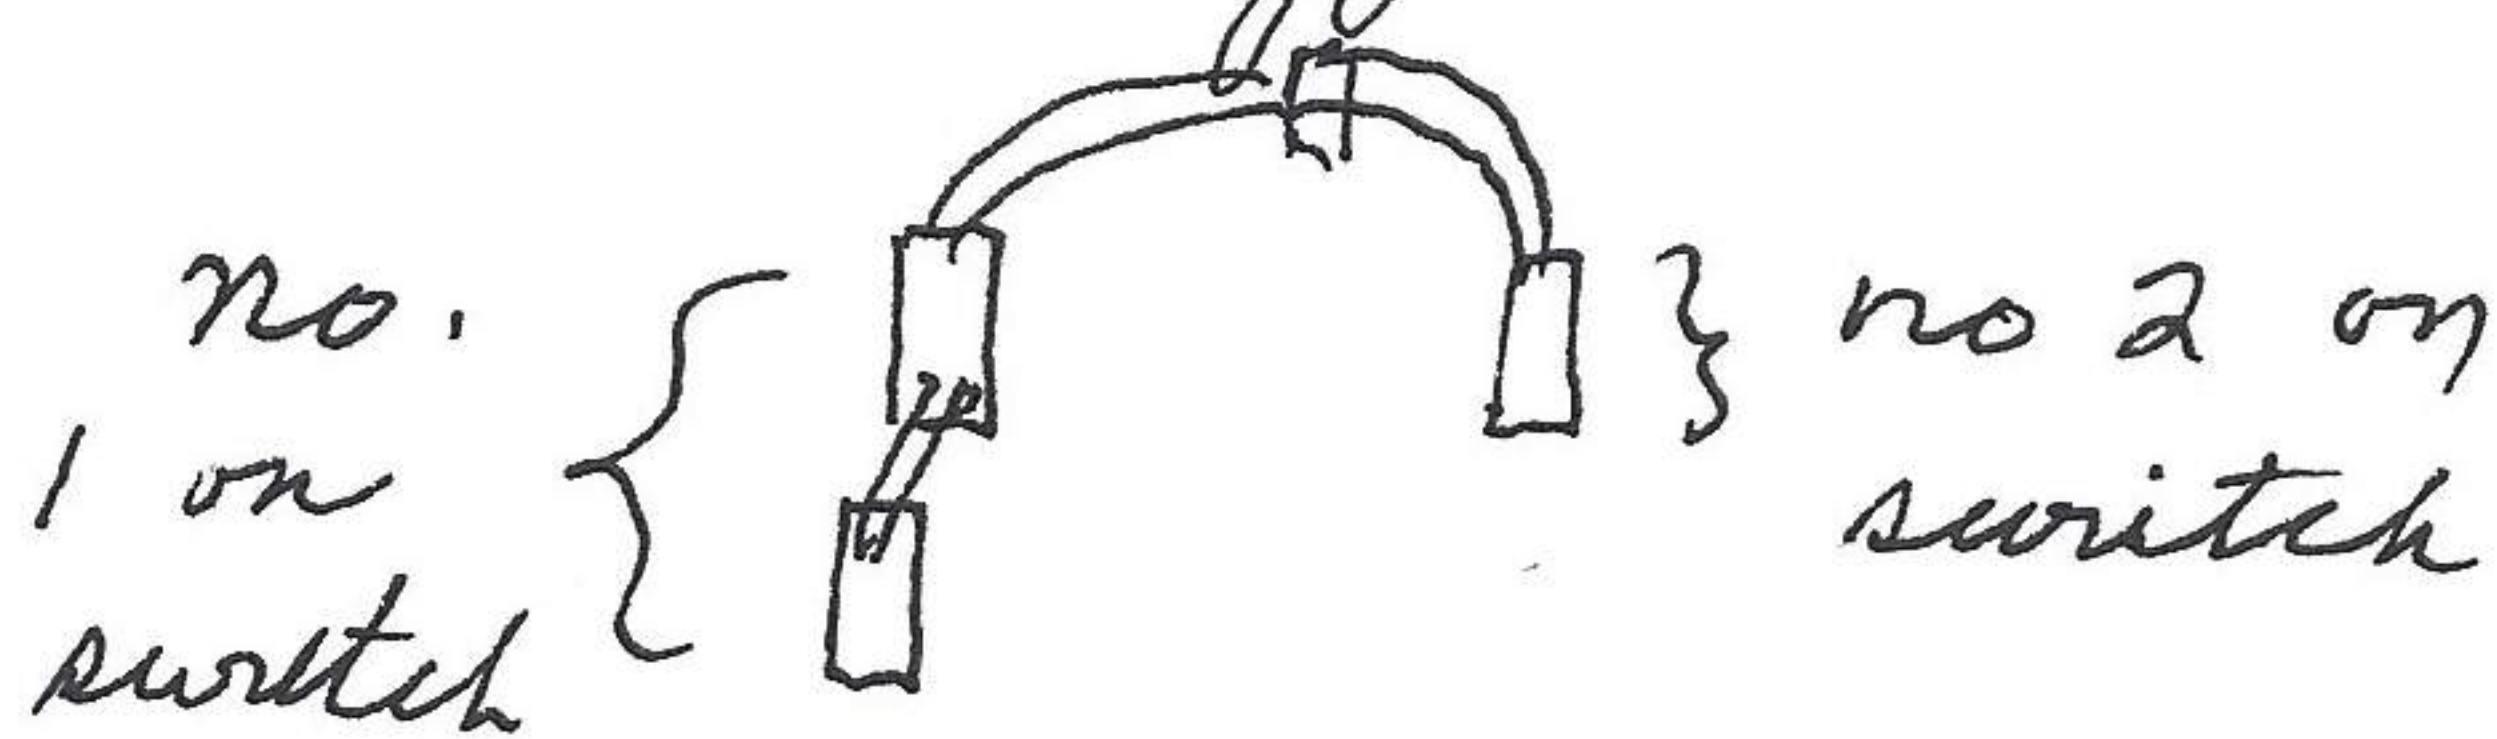
1. replaced one battery because of loose stem with equivalent 40 Fisk, 900 cold cranking hours. The old battery had been made in Seattle and this battery had not been manufactured in the last 6 years. all batteries topped with water.

2. Red no 2 was moved to port side and new battery put into 2 battery position.

3. added terminal to ground no 2. motor started on no 2 only.
